# Manhole Inspection Summary

Manhole # S25A\_\_001MH

Insp Date: **8/20/07 8:57 AM**

**Location** Address: **1206 EDMONDSON AVE**

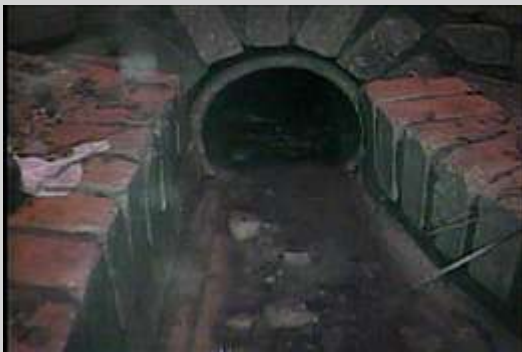
12 O'Clock Outflow

8 in. Circular Gravity Sewer  
Pipe Out @ 12 O'Clock

Pipe Height: **8.4** (in.) Rod and Bar (Angled)  
Pipe Material: **Clay** ☐ Pipe Lined  
Invert Depth: **10.71** (ft.) Flow Characteristics: **Slow**  
Deposits: ☒ None ☐ Mud ☐ Sludge ☐ Debris ☐ Grease  
Silt Depth: (in.) Deposits Extent:  
Infiltration: **None** Pipe Seal Cond: **Sound**

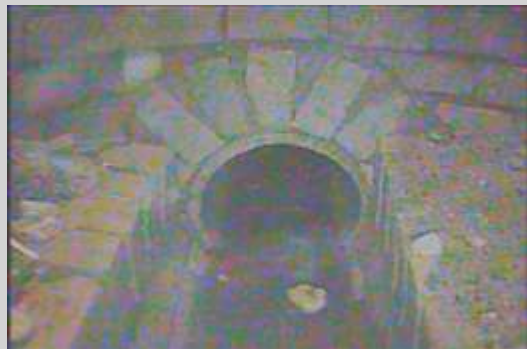
6 O'Clock Inflow

8 in. Circular Gravity Sewer  
Pipe In @ 6 O'Clock

Pipe Height: **7.2** (in.) Rod and Bar (Angled)

Infiltration: **None** Pipe Seal Cond: **Sound**
